CHAPTER **6 Materials for Hull Construction –  
Fiber Reinforced Plastics (FRP)**

SECTION **6 Repair**

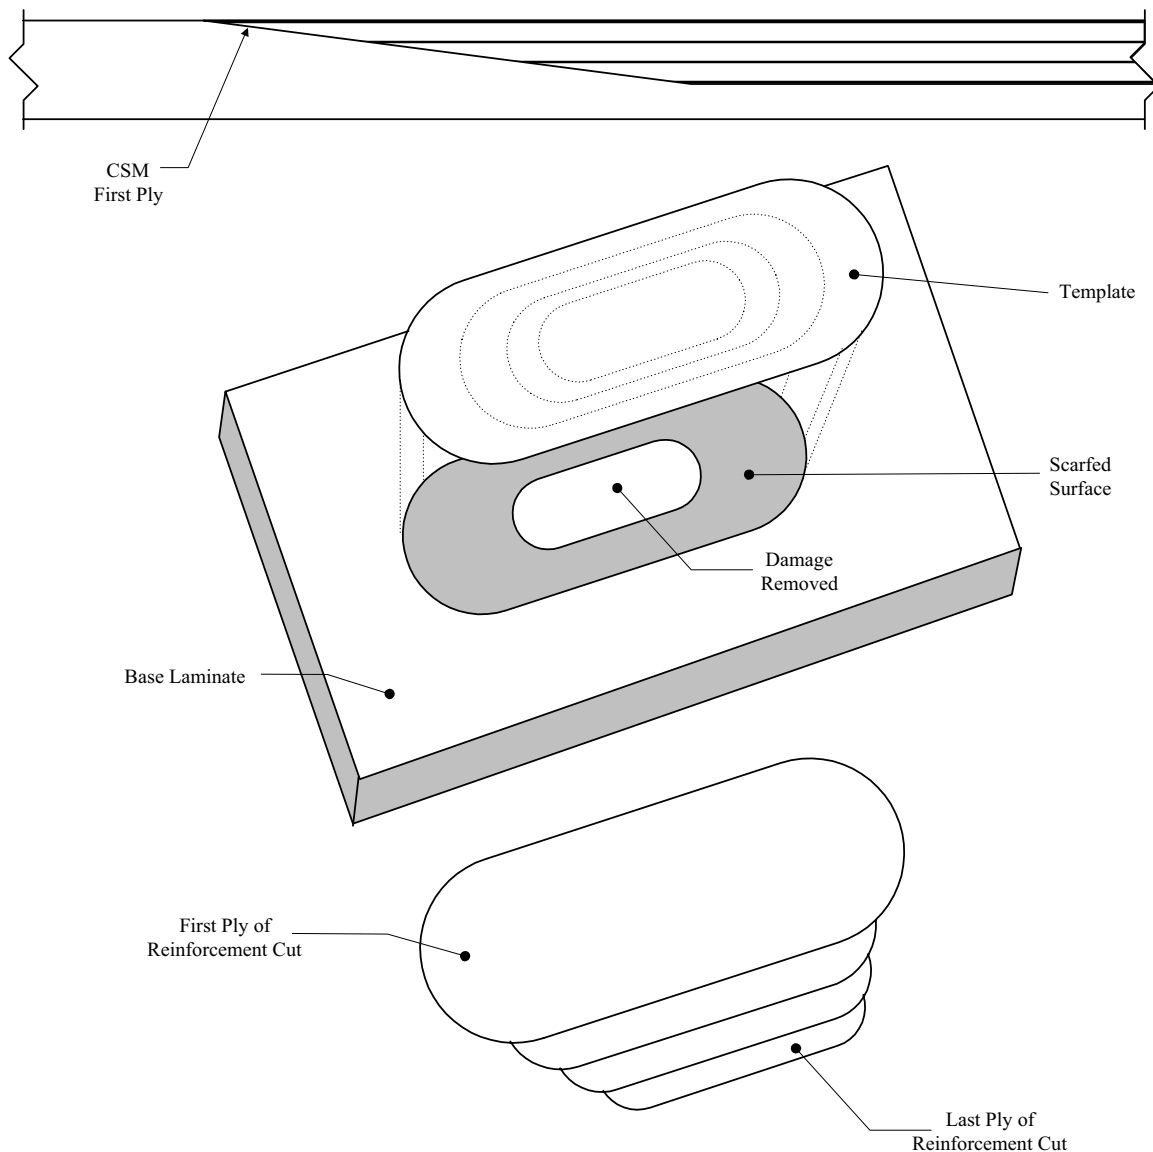
**FIGURE 2**  
**Repair Sequence**

#### BUTTED LAY-UP

All laminating procedures consist of using secondary bonding and the requirements in 2-6-3/9.13 are applicable. Generally, the lay-up is to have the smallest ply first with each successive ply being larger, as indicated in 2-6-6/Figure 2. Each of the successive plies are to be slightly oversized and trimmed as it is being laminated in place. Care is to be taken in using undersized plies as this may create a resin pocket along the bond line. The fiber orientation is to be maintained during lamination. Alternative methods for laminating will be subject to special consideration.

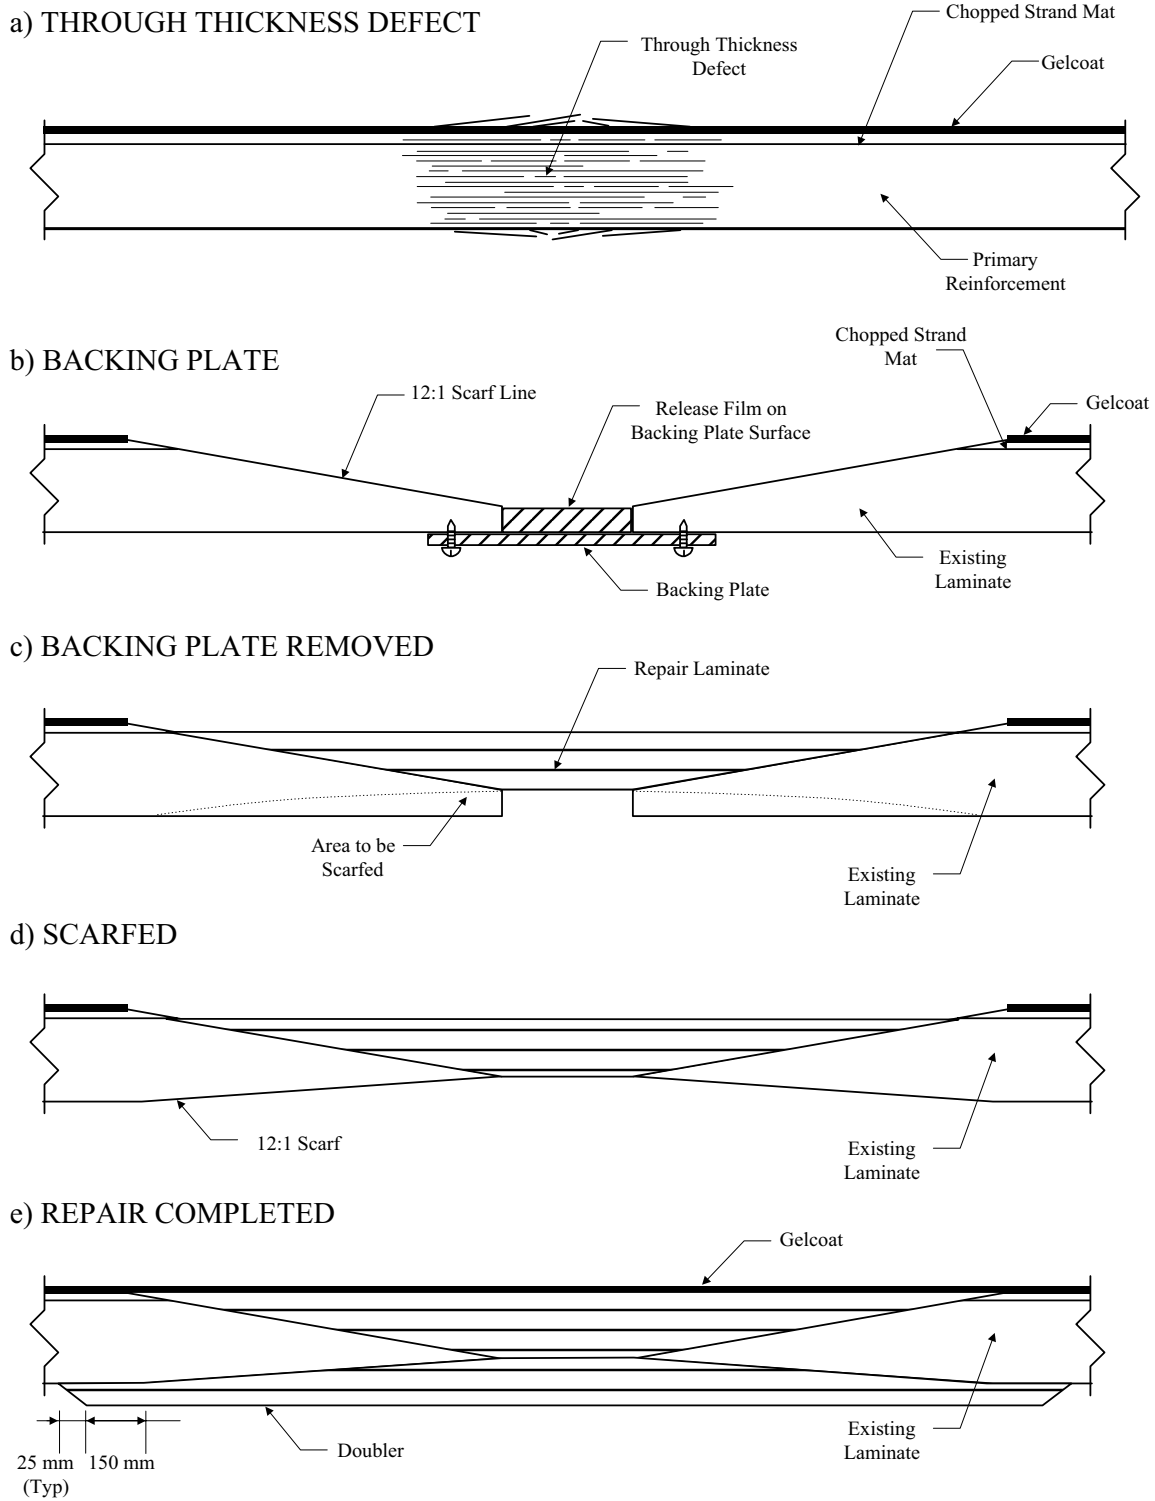
**FIGURE 6**  
**One Sided Scarf Repair – Backing Plate Installation**

Note: Repair shown with additional plies onto non-molded side.

In all cases, the first ply applied to the existing surface is to be chopped strand mat. This layer is to cover the entire faying surface and is to be saturated in the laminating resin. The laminating procedures, as outlined in 2-6-3/9.7, are to be followed. When lamination is required on an inclined or overhead surface, precautions are to be taken so that the wet reinforcements do not fall. Acceptable laminating repairs can be seen in 2-6-6/Figures 4 through 11.

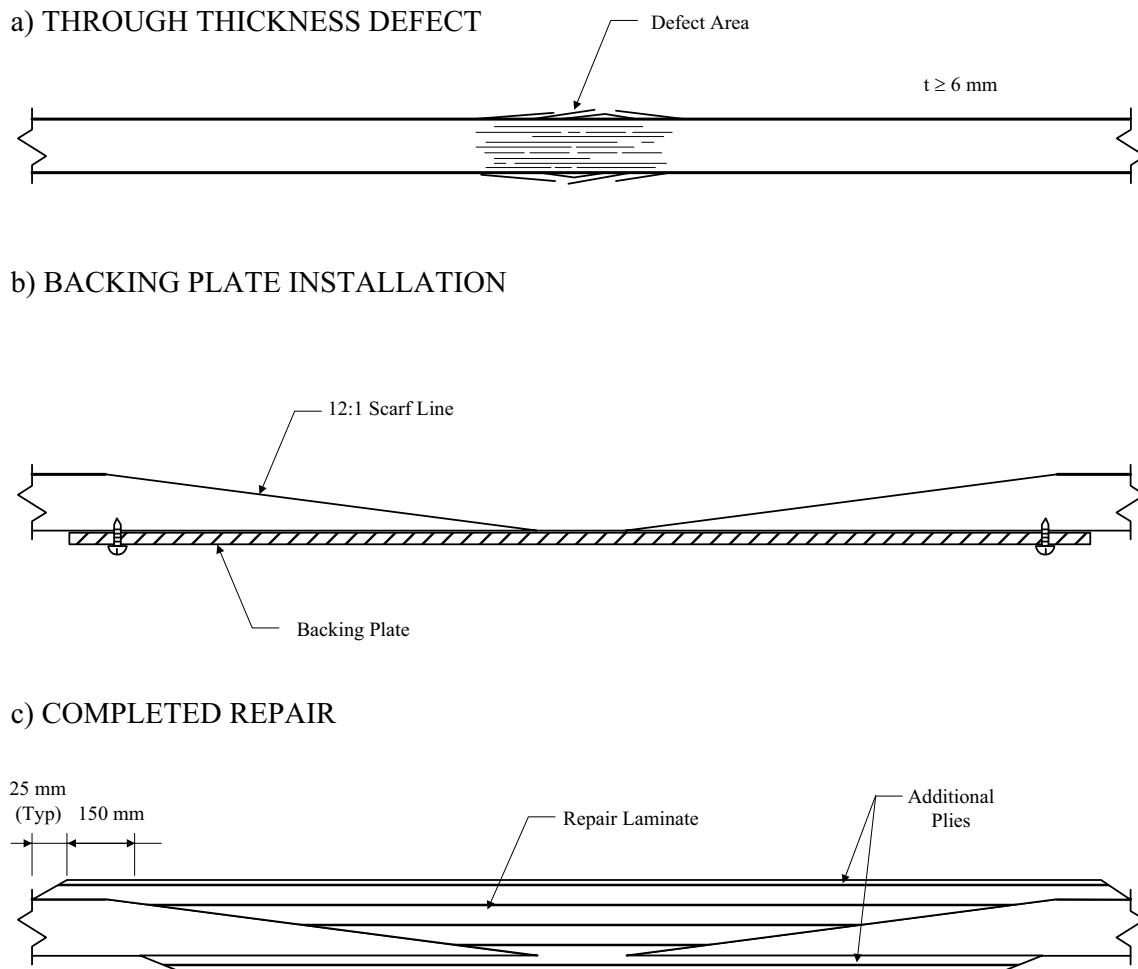
**FIGURE 8**  
**Single Sided Scarf Repair on Thin Laminate**

Note: Repair shown with additional plies onto non-molded side.

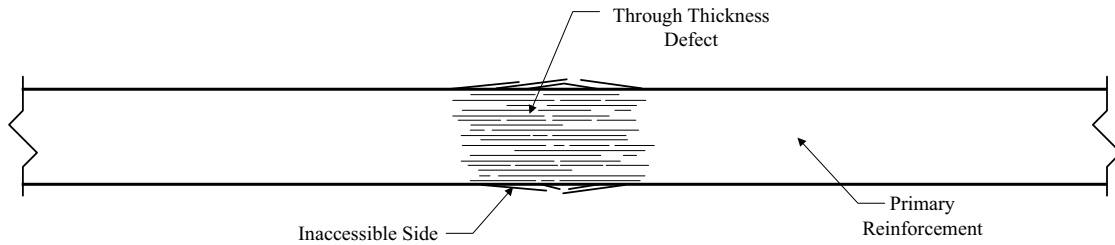
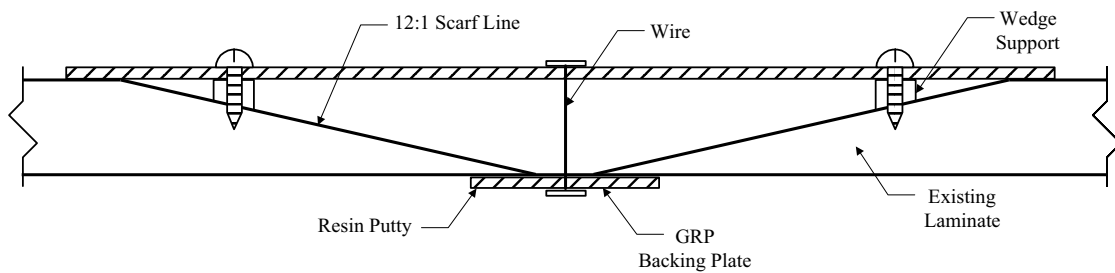
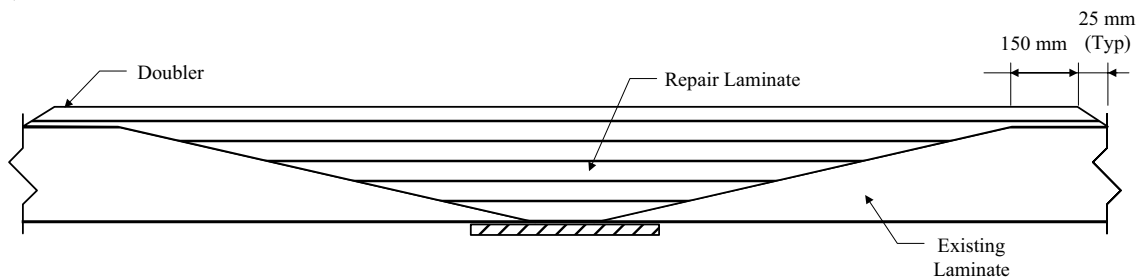
**FIGURE 9**  
**Backing Plate Installation – Access from One Sided Repair**

a) DEFECTIVE LAMINATE

b) BACKING PLATE INSTALLATION

c) COMPLETED REPAIR

*Note:* Repair shown with additional plies onto non-molded side.

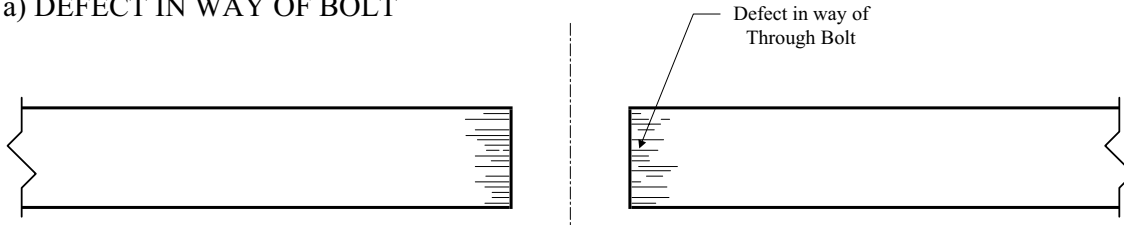
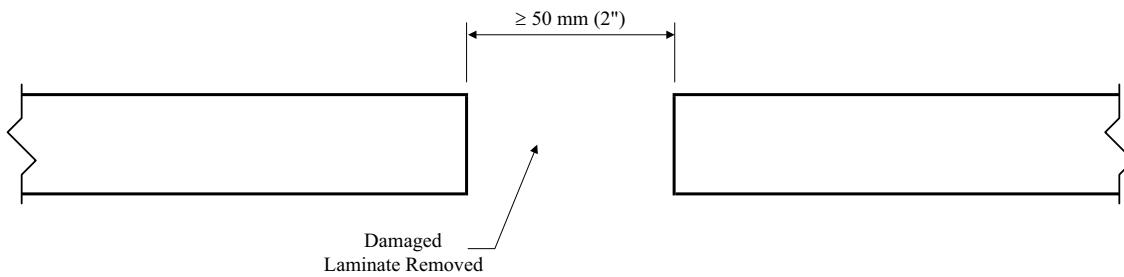
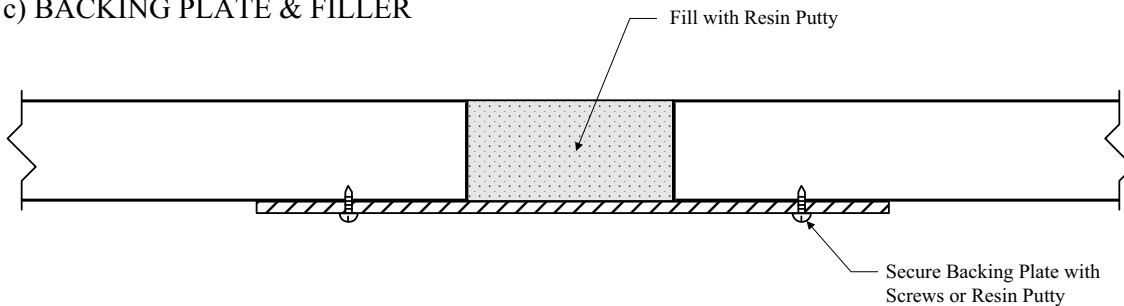
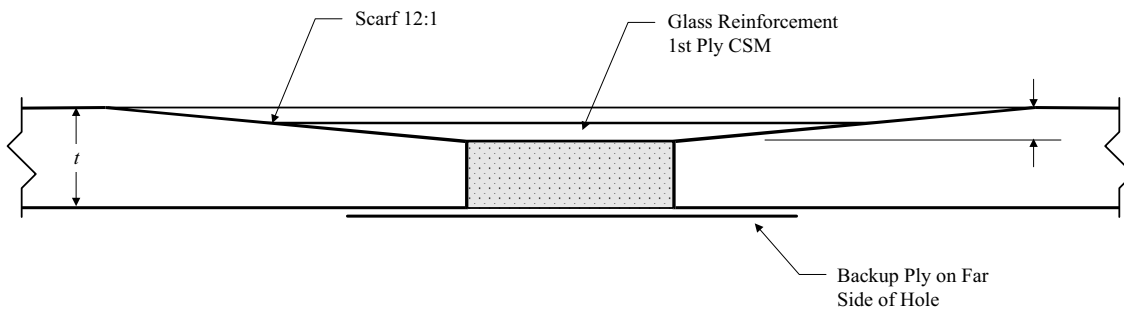
**FIGURE 10**  
**Repair in Way of Through Bolt Failure**

a) DEFECT IN WAY OF BOLT

b) LAMINATE REMOVAL

c) BACKING PLATE & FILLER

d) COMPLETED REPAIR

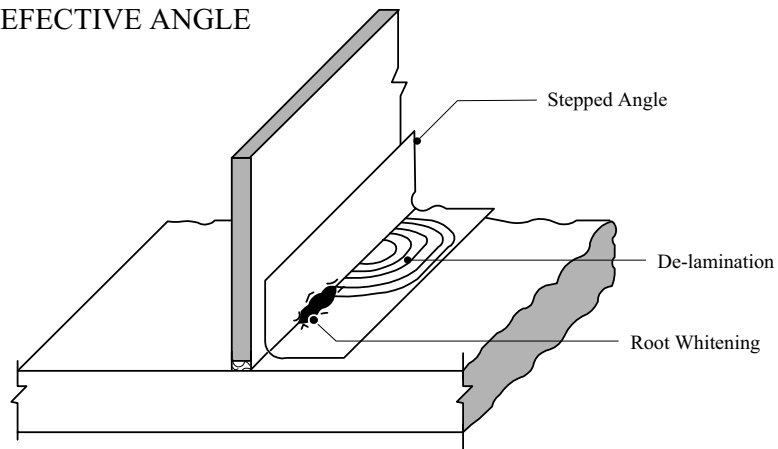
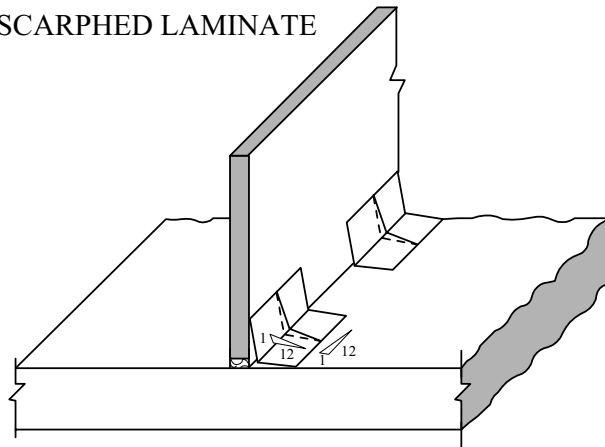
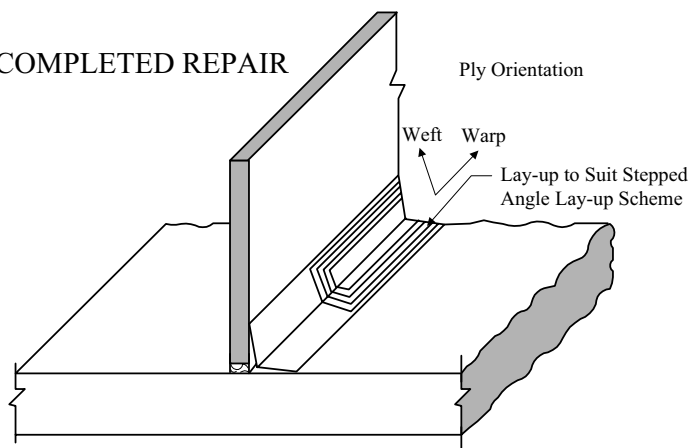
**FIGURE 11**  
**Stepped Angle Defect Repair**

a) DEFECTIVE ANGLE

b) SCARPED LAMINATE

c) COMPLETED REPAIR
